Helical Tieback Anchors Repair and Restore Tilting Foundation Wall

Denver, Colorado

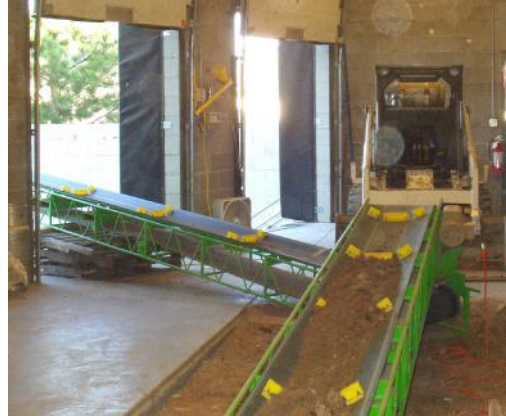
Top photo: The slab and soil was removed by conveyor.

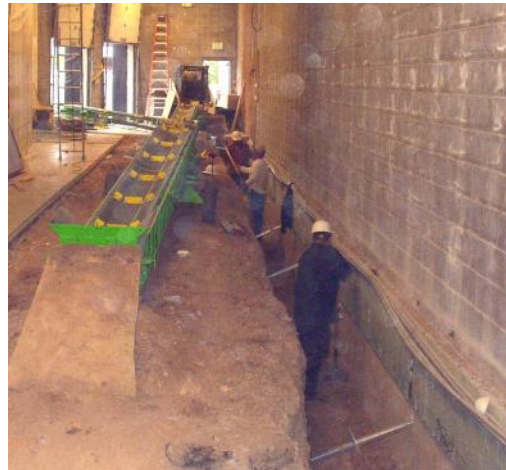
Middle: Workers dig soil from behind the stem wall.

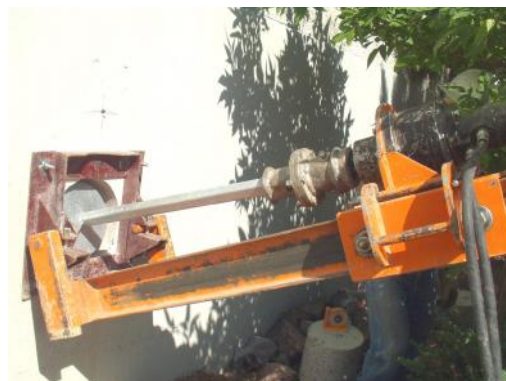
Above: A Torque Anchor™ is installed from outside at the specified downward angle.

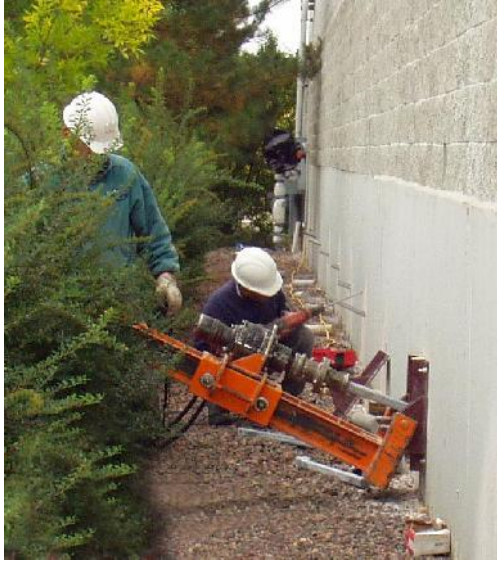
The technicians use a hydraulic gear motor to advance a helical Torque Anchor™ through the wall and into the soil below the building.

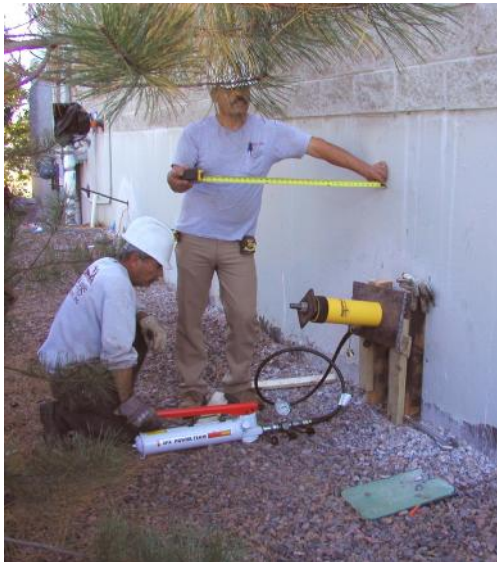
One technician applies a hydraulic force against the wall while the other holds a tape measure. A third technician (not visible) monitors the wall restoration.

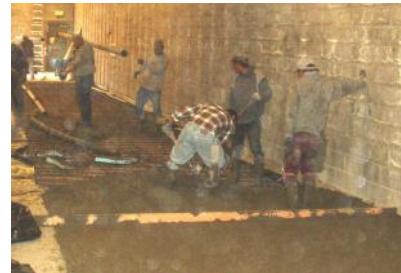
The excavated area behind the stem wall was filled, compacted and then steel reinforcement was installed.

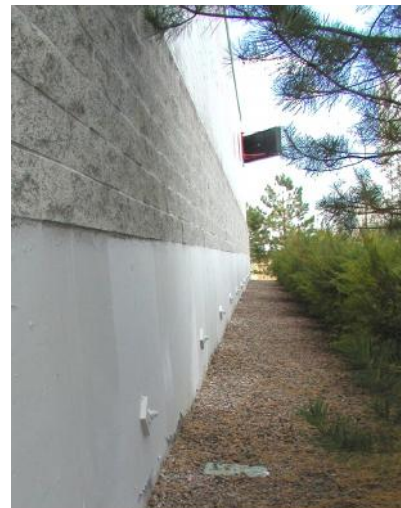
At right is a view of the restored wall. The wall plates are the only evidence of the work.
