Case History

ECP Slab Piers Repair 160 PPB-166 Slab Piers

Office Building Settled in Florida

Located Over Four Feet of Compressible Organic Soil

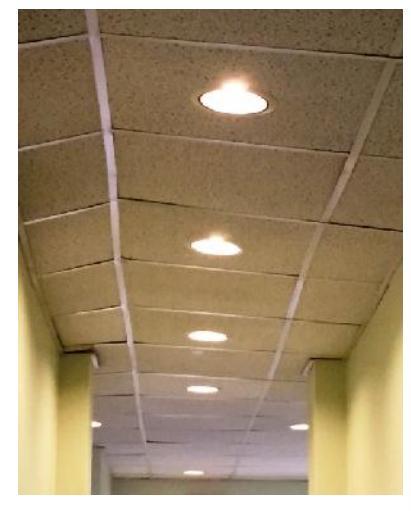
An office building in Palm Beach County, Florida, built in 1989, experienced slab settlement. The 11,150 ft² structure uses structural columns supported upon deep foundations, with a floating concrete slab on the interior. Significant distress occurred inside the building as seen in the photographs. The movements were caused by differential settlement of the slab. Soil testing revealed that the settlement was due to a stratum of highly organic soil located seven feet below grade and extending to eleven feet.
