Helical Tieback Anchors Repair and Restore Tilting Foundation Wall

Denver, Colorado

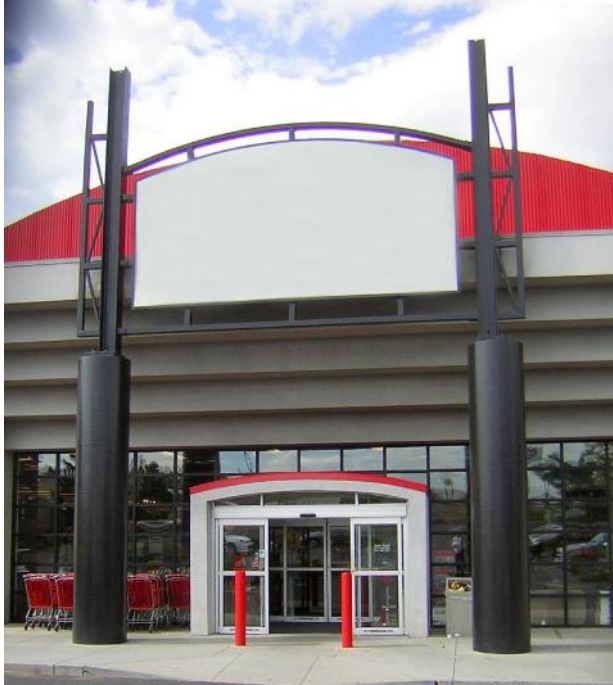
The owners of this chain store contacted JR Harris & Company Structural Engineers after noticing distress along the walls and large cracks in the floor caused an unsafe working environment. The building was constructed on a site containing fill soil. In addition there was a lateral load on the stem wall caused by fill against the stem wall interior to raise the slab to the finished floor elevation. The lateral force of the soil under the slab was causing the outward rotation of the stem walls. The project required removing a portion of the concrete floor slab and the soil that was below the slab.

Helical Torque Anchors™ were installed to provide supplemental lateral wall support and to restore the stem walls plumb (vertically upright). All of this work had to be accomplished while the retail business remained open.

Solid square shaft ECP TAF-150-60 8-10 Torque Anchor™ Tieback Anchors were installed through the wall and to a distance of 25 to 35 feet before reaching suitable shaft torsion to provide a working capacity exceeding 7,000 pounds at each placement.

Once the Torque Anchor™ Tiebacks were installed, the wall was moved back to plumb using a series of hydraulic jacks. The wall was moved 3 to 4 inches. The only evidence of the work is the row of wall plates and nuts that are visible along the exterior surfaces of the stem walls.

After the walls were realigned, select fill soil was carefully placed into excavated areas and compacted and a new reinforced concrete floor was cast.
